Atlas of the alluvial gravel-bed reach of Fraser River in the Lower Mainland showing channel changes in the period 1912-1999

Michael Church and Darren Ham
Department of Geography
The University of British Columbia
Vancouver, British Columbia V6T 1Z2

15 October 2004

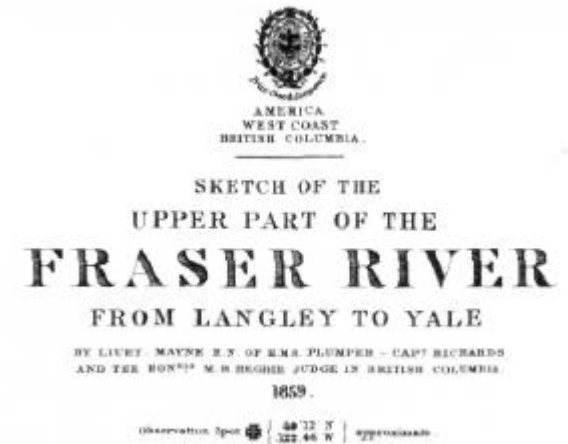
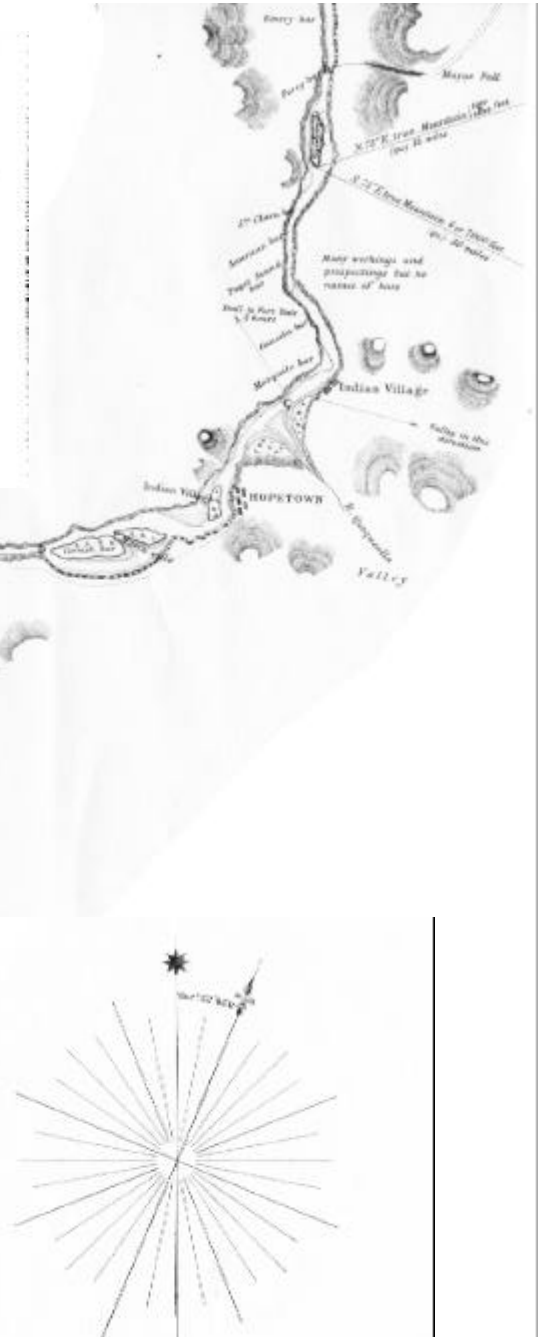
Location map showing major sub-reaches used throughout manuscript and km markers showing the cumulative distance upstream from Sandheads.

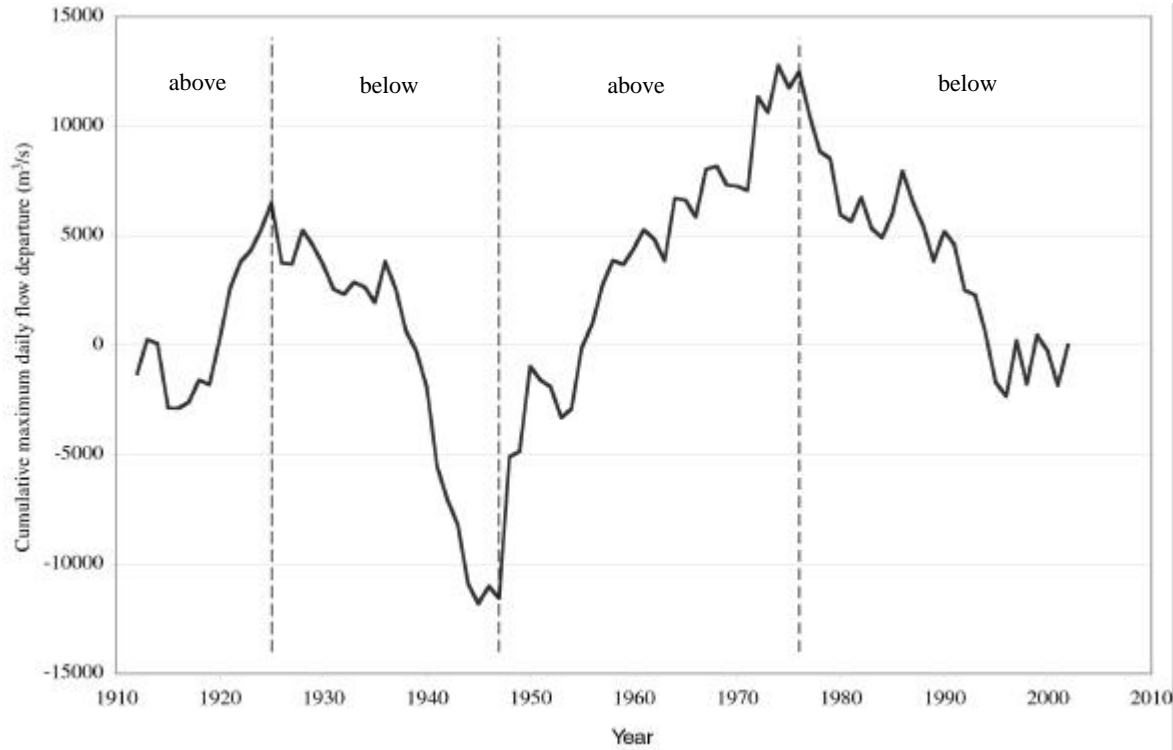
Figure 3. Cumulative flood flow departures showing principal trends in flows compared to long-term mean discharge. A rising graph indicates a period of persistently *above* average annual floods, whilst a falling graph indicates persistently *below* average floods.

floods while the following period to 1947 had mainly below average ones. From 1948 to 1976 floods tended to be very high (7 of the 11 highest flows occurring in this period), and then low to near the end of the record (see Figure 3).
